TECHNICAL MEMORANDUM

Cedar Key City Hall

To: City of Cedar Key Commission
From: Gerry Dedenbach, AICP + LEED AP / Adam Gayle, AIA
Date: June 25, 2024
RE: Cedar Key City Hall Due Diligence / Restoration Evaluation
Attendees: The Honorable Sue Colson-Mayor, Jamie McCain, Adam Gayle, and Gerry Dedenbach

OBSERVATION REPORT AND RECOMMENDATIONS FOR CEDAR KEY OLD CITY HALL FLOODING, STURCTURAL, AND FOUNDATION ISSUES

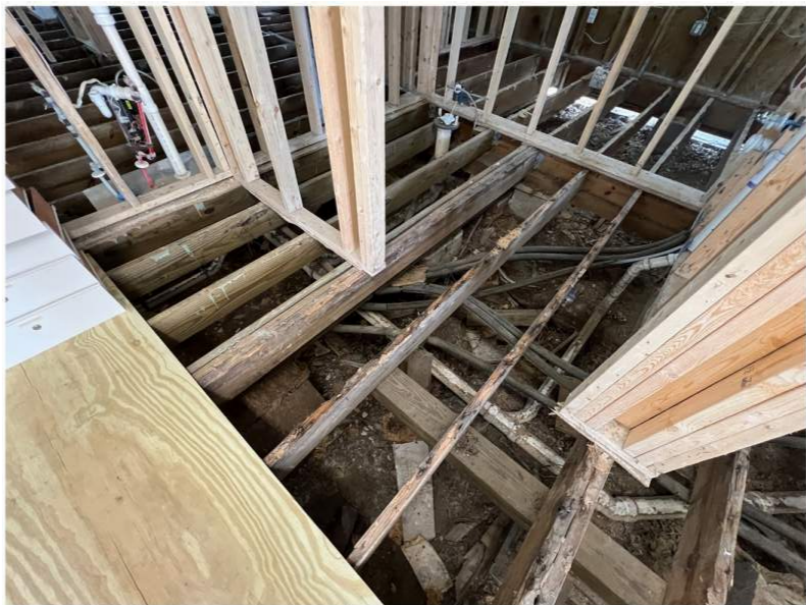
Beams Supporting Floor not Continuous under Joists.

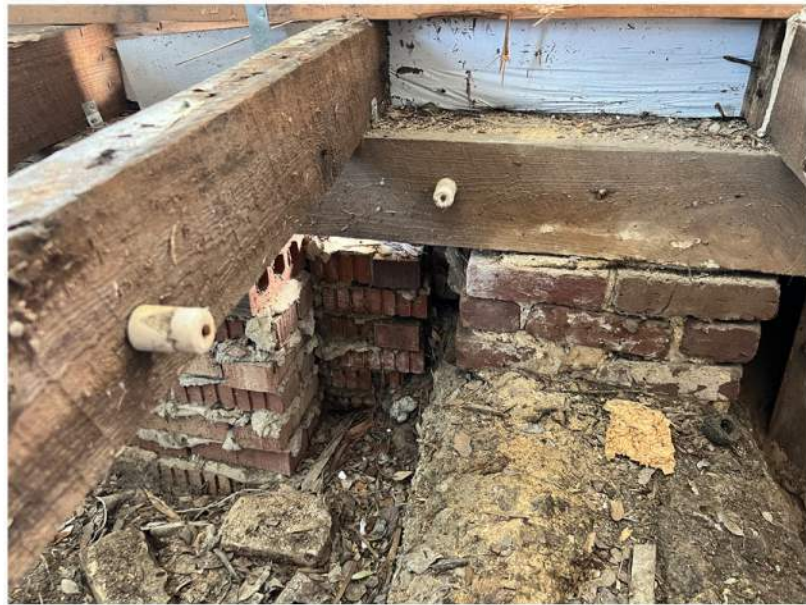
Brick and Mortar in Poor Condition

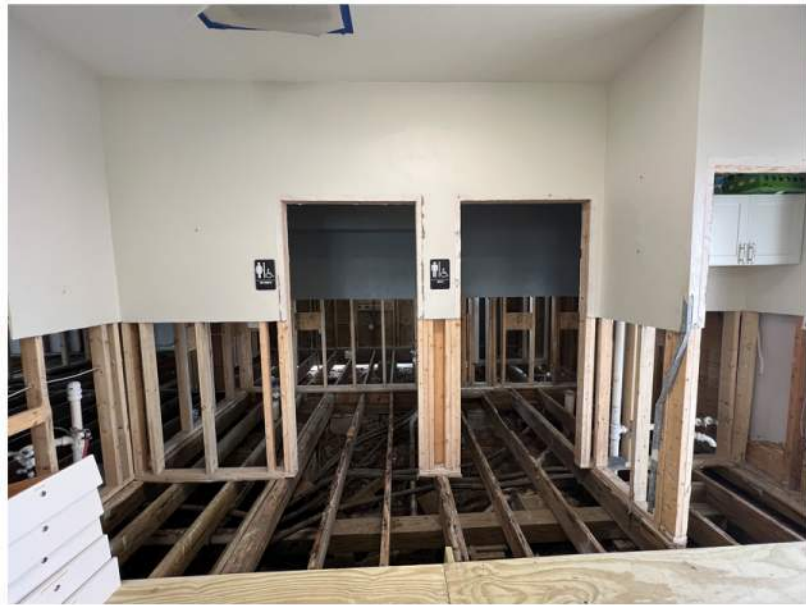
Note: Sole or bottom plate floating on joists and irregularly spaced joists and framing throughout

Damaged Floor Joists

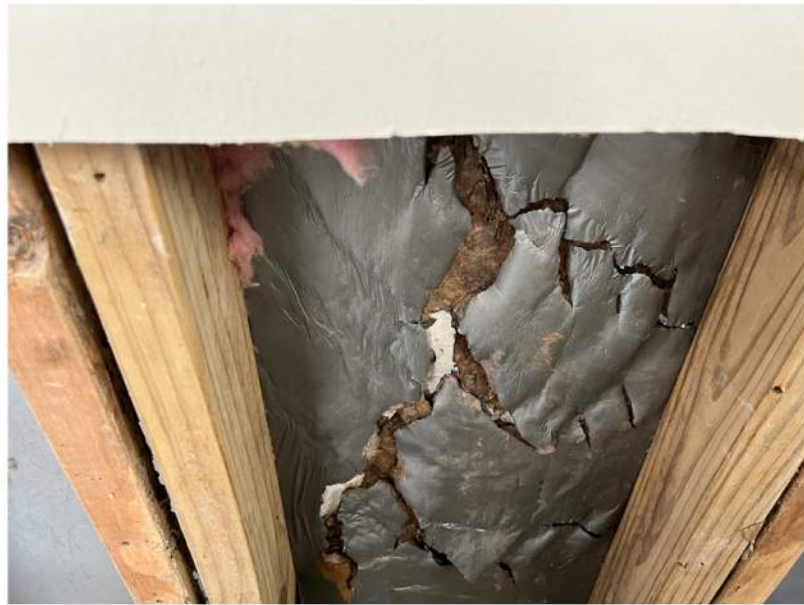
Damaged Insulation and Moisture Barrier

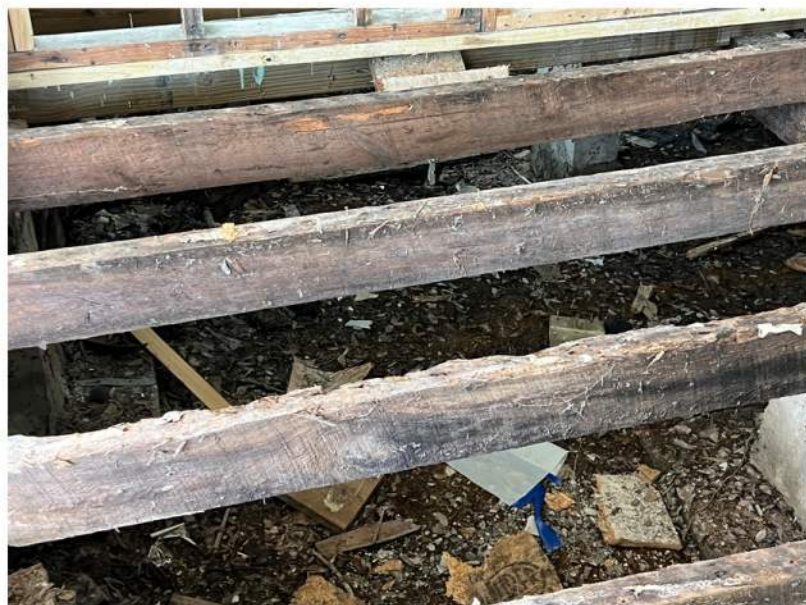
Note: No cross bracing present on lengthy joist spans

Degradation at Floor Joists

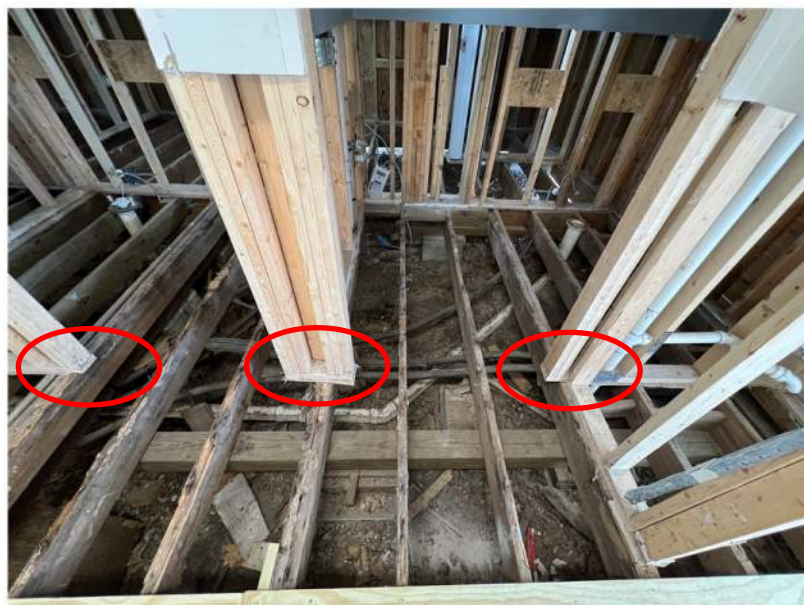
Note: No ledger or cross bracing present

Floor Joists in Poor Condition and on Multiple Foundation Types

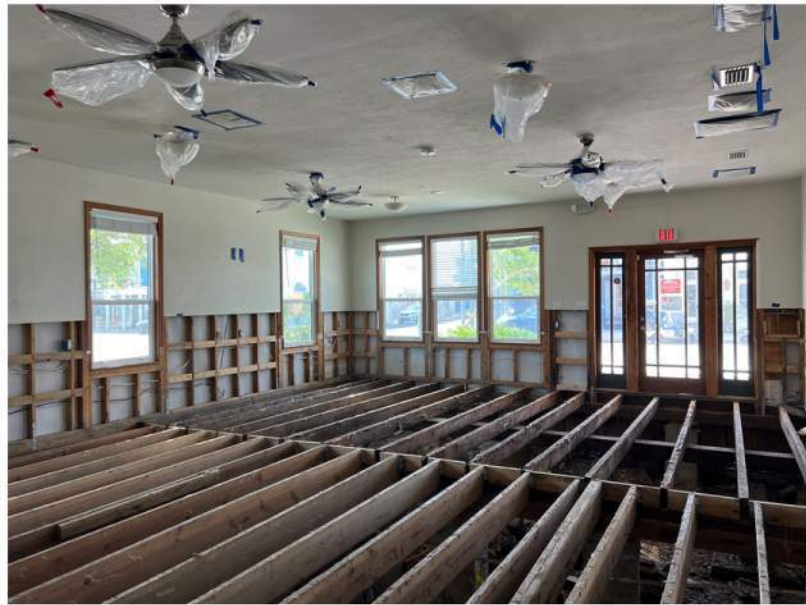
Floor Joists Missing Hangers - Visible Moisture Present in Soil Under Bui...

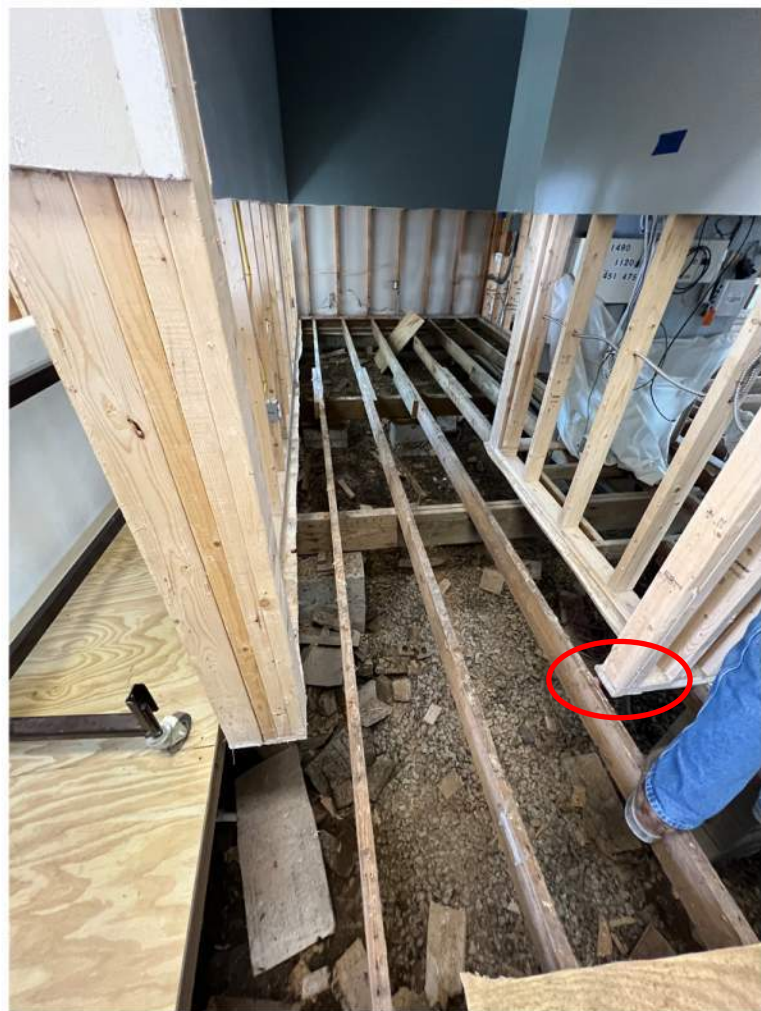
Floor Joists not Anchored to Foundations

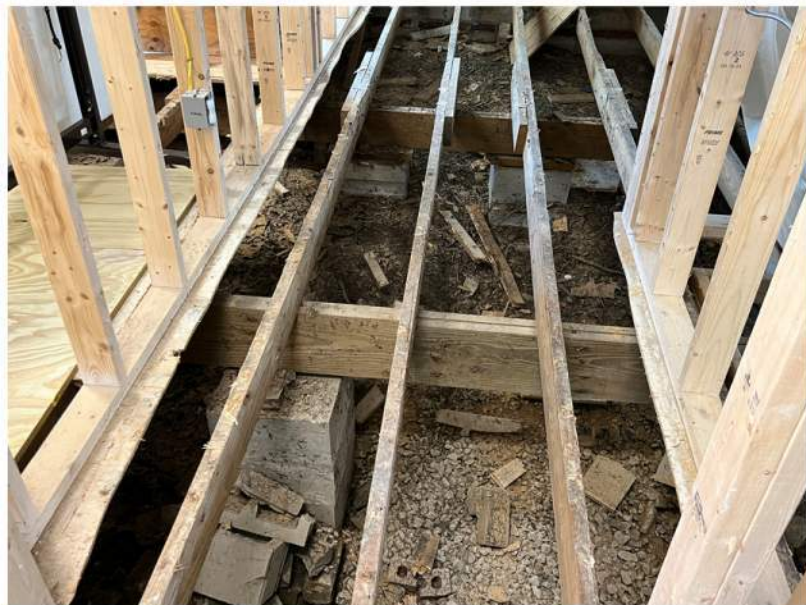
Floor Joists not Anchored to Foundations

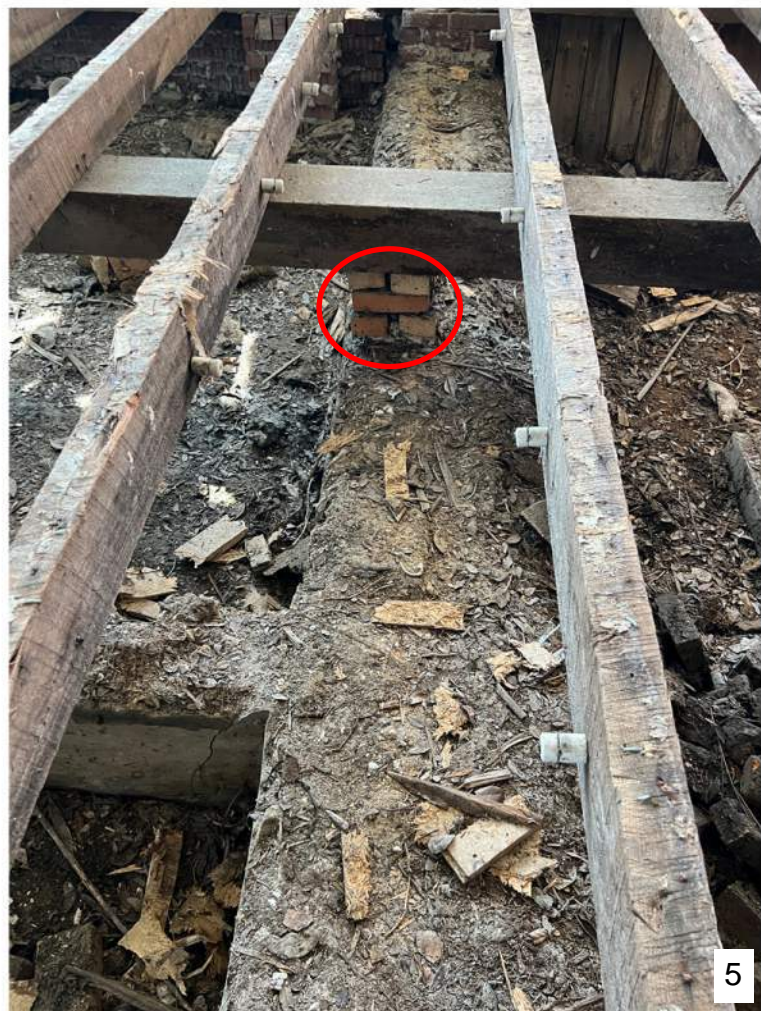
Floor Joists Unattached to Brick on Original Concrete Foundations

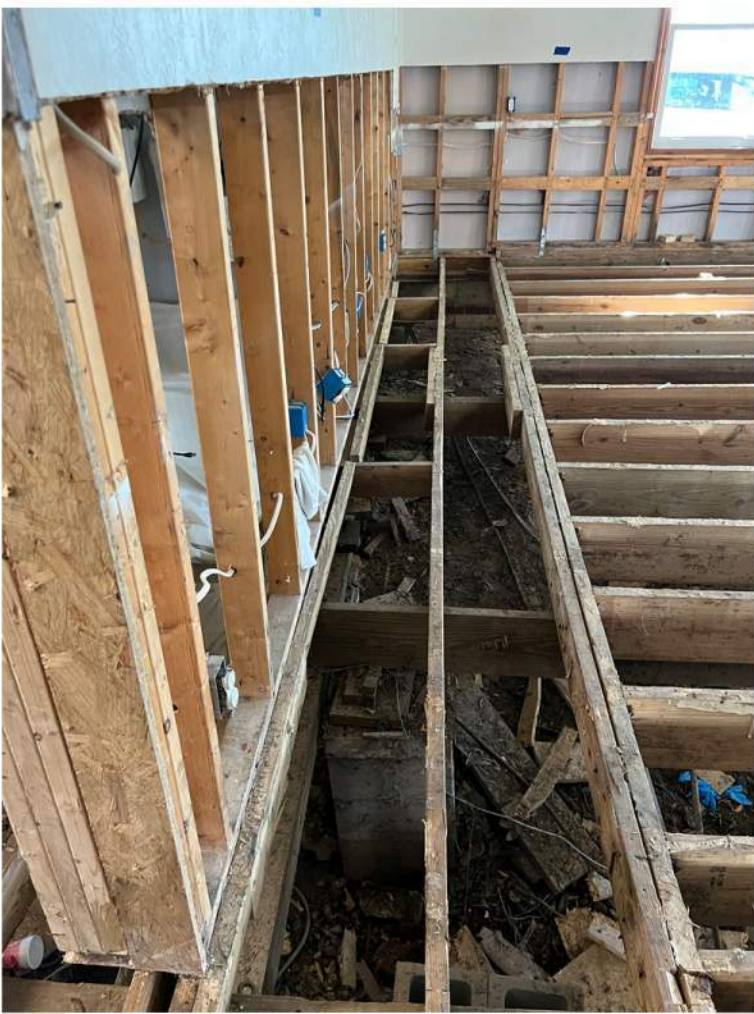
Framing between Renovation Phases

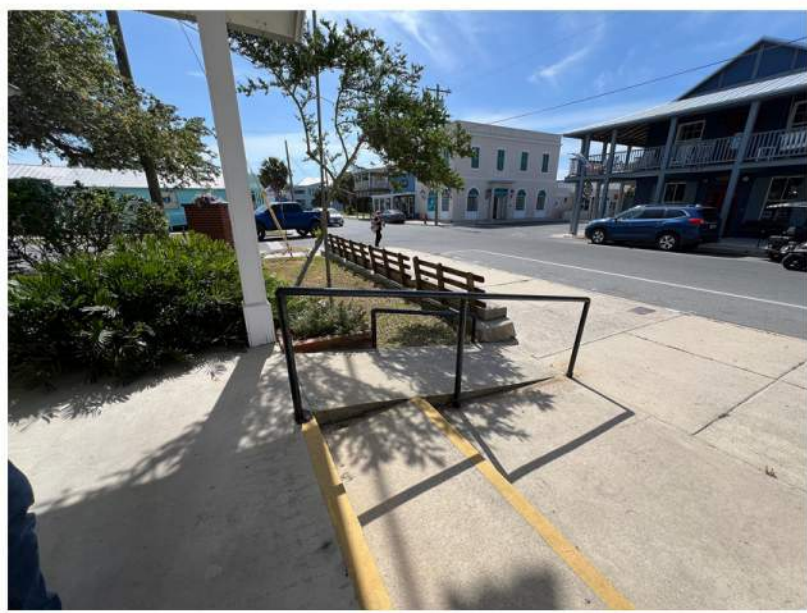
Front Entry and Rails not Code - ADA Compliant

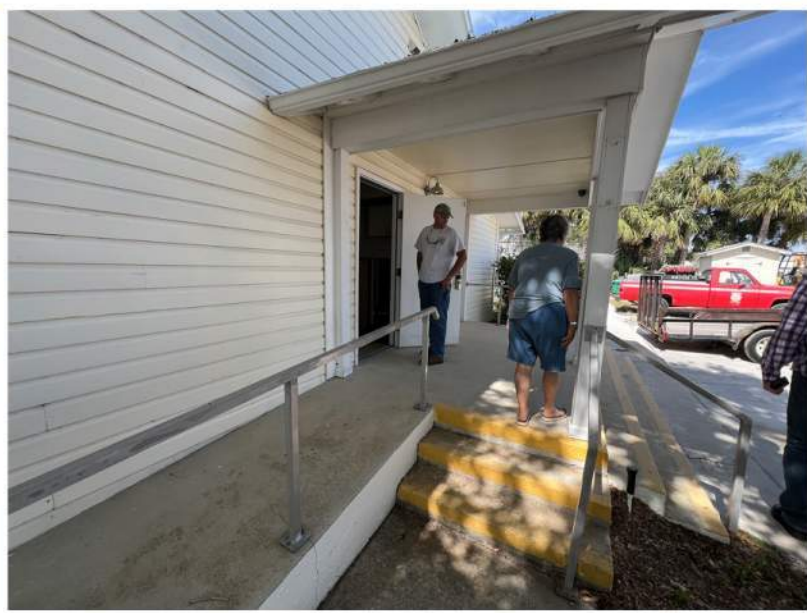
Handrail-Gaurdrail Not Code Compliant

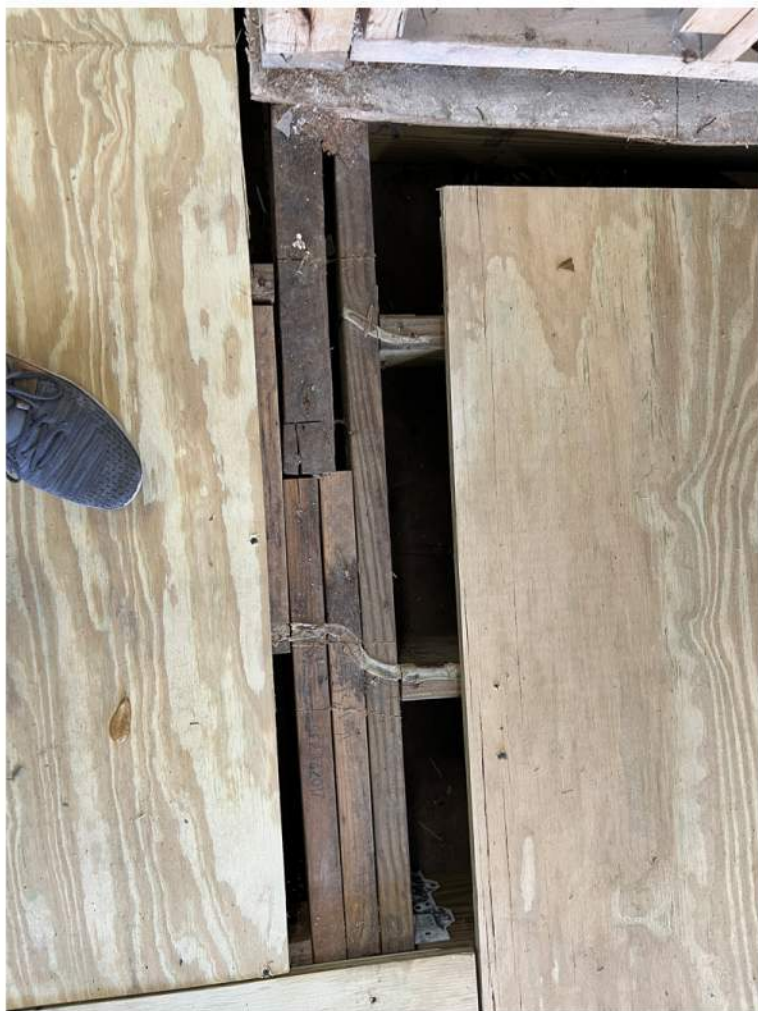
Improperly Lapped Floor Joists

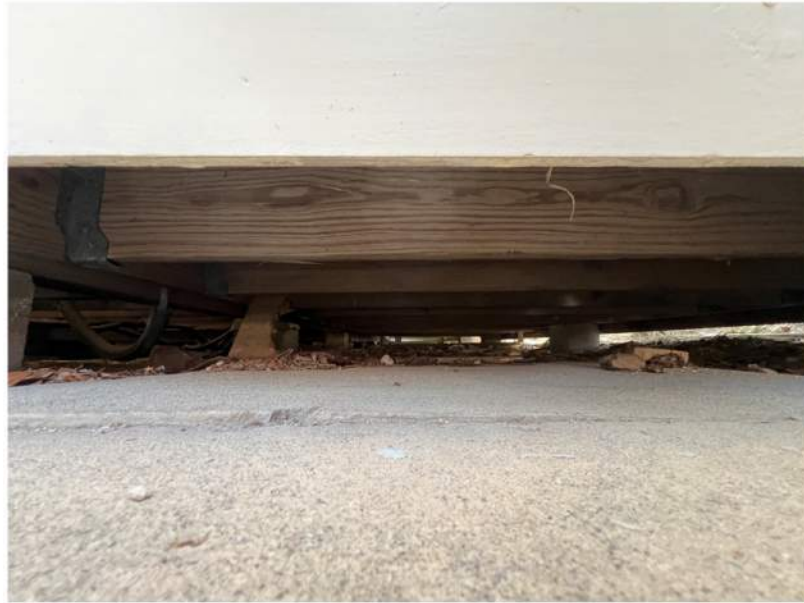
Indications of Animals Inhabiting Crawl Space

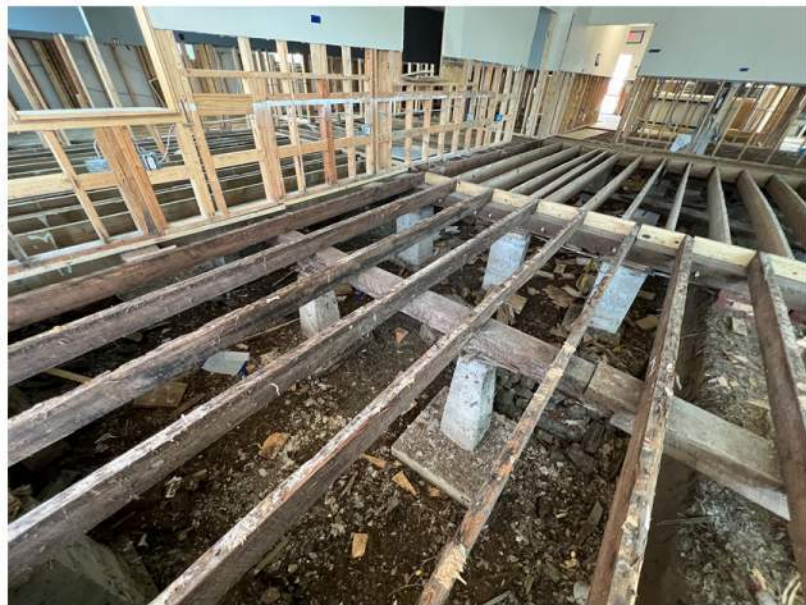
Joists not Anchored to Supports

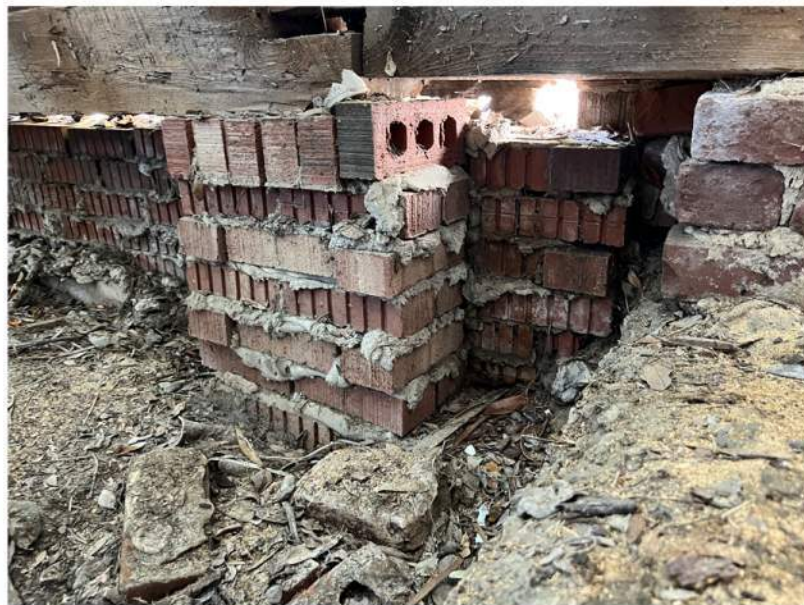
Joists Not Connected to Brick

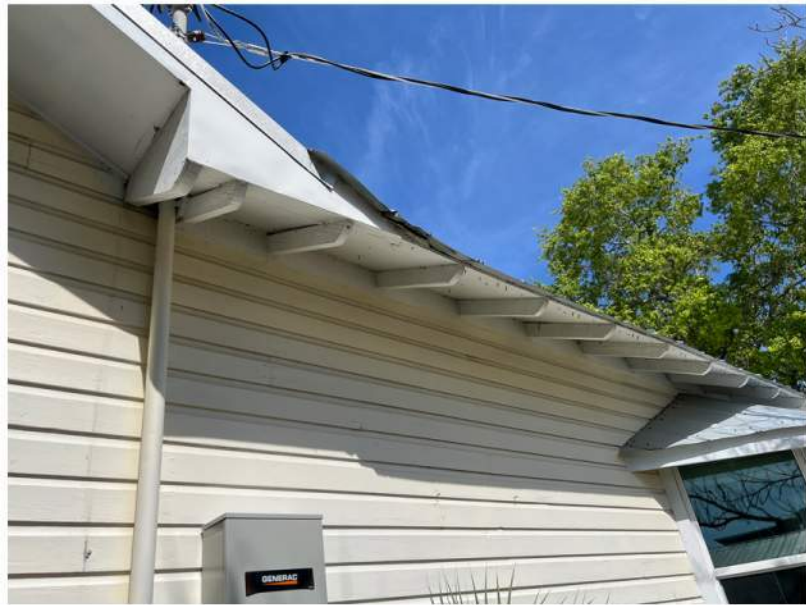
Minor Roof Damage at Fascia

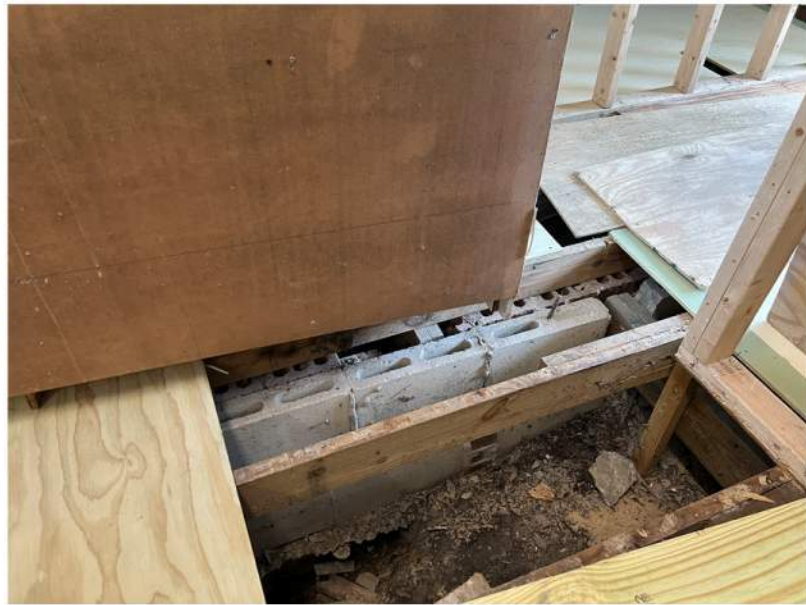
Miscellaneous Unconnected CMU Foundations

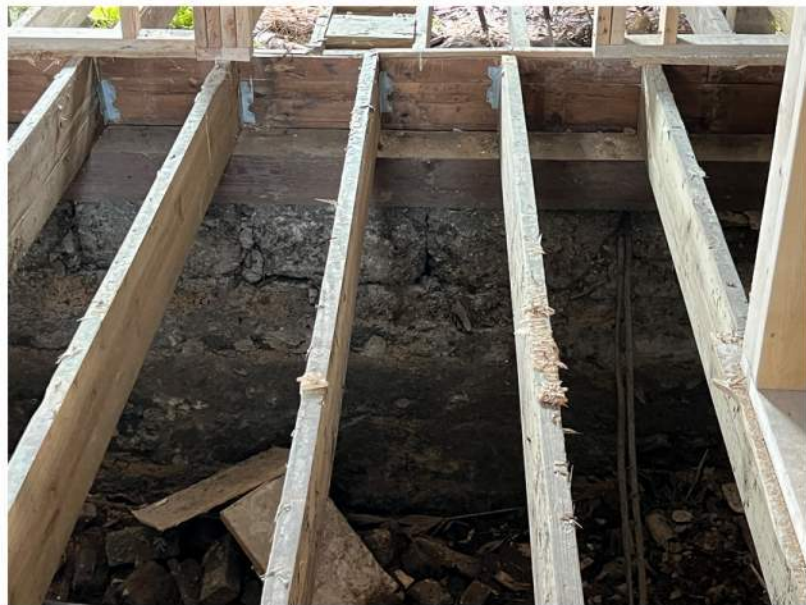
Original Foundations Visible

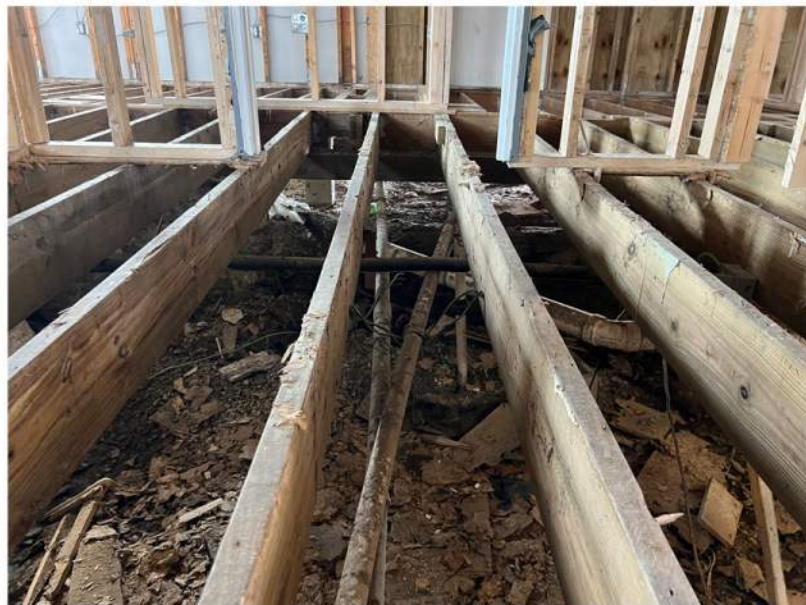
Plumbing Lines not Supported

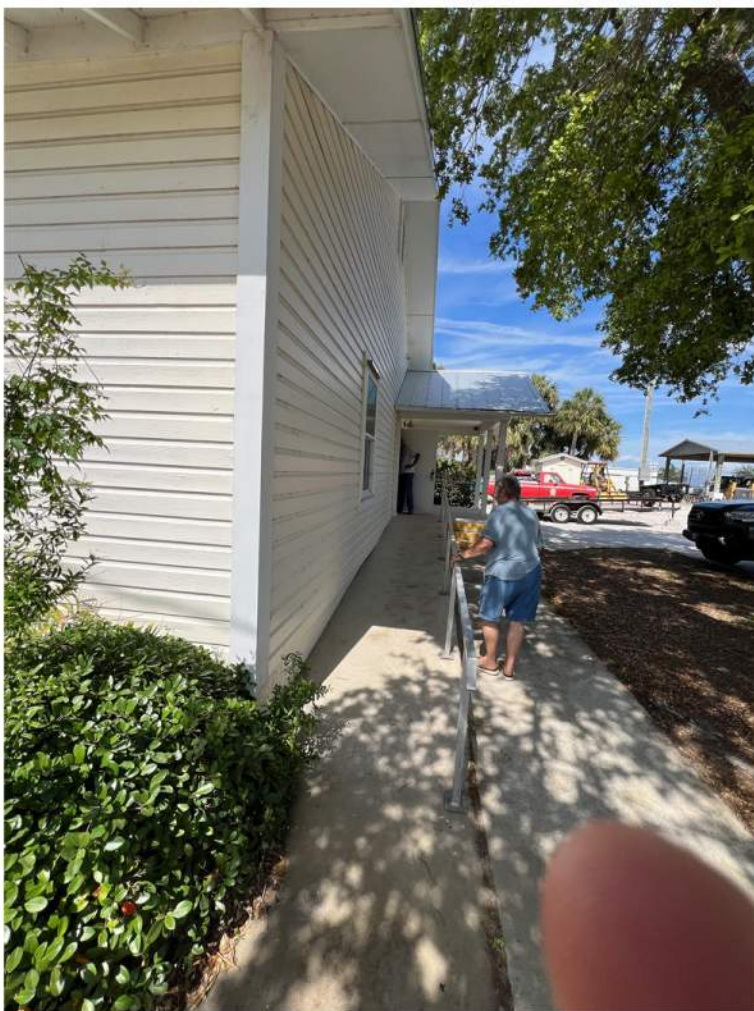
Ramp - Not ADA Compliant

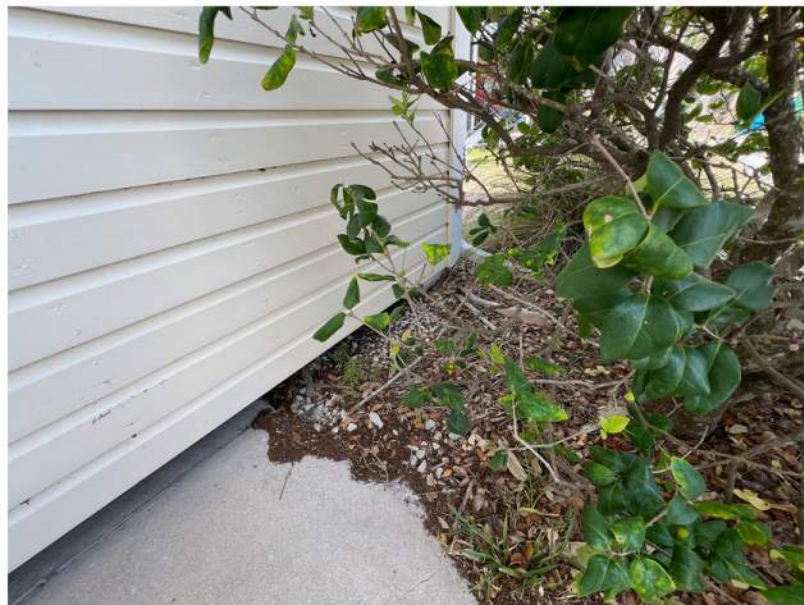
Siding in Visibly Acceptable Condition

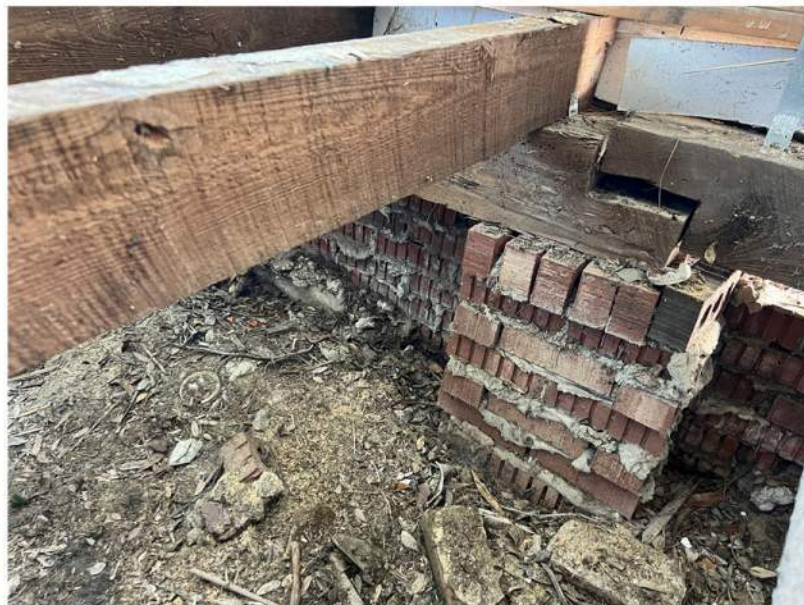
Signs of Movement at Wood Beams

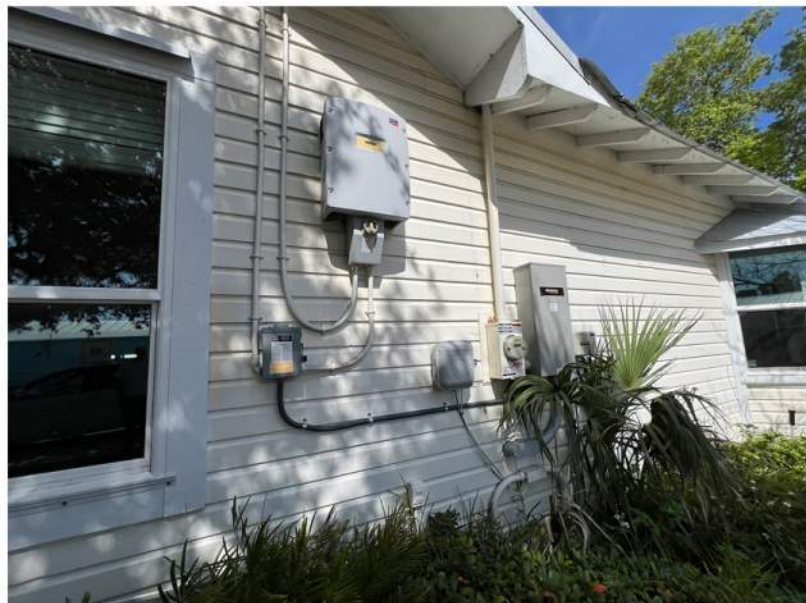
Utilities and Overgrown Vegetation Against Building

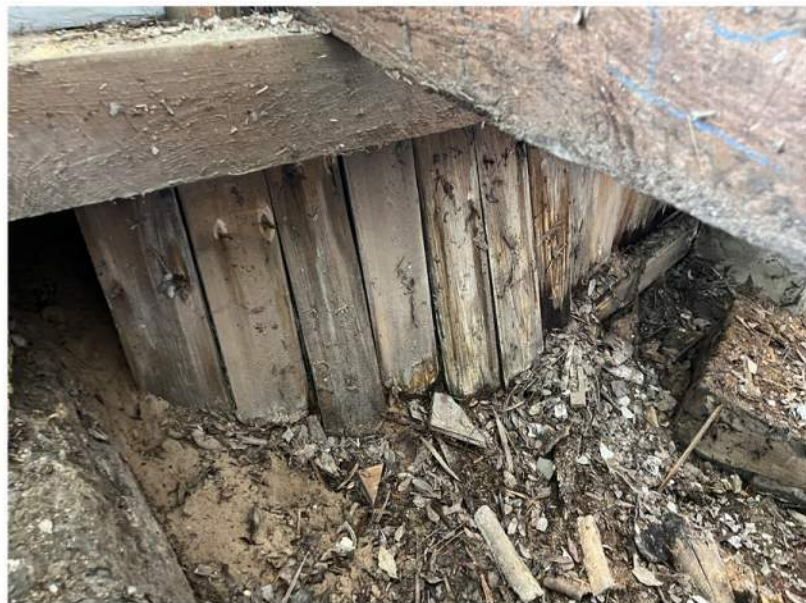
Water Damage to Wood
